www.mbsm.pro , when capacitor explodes , Pictures

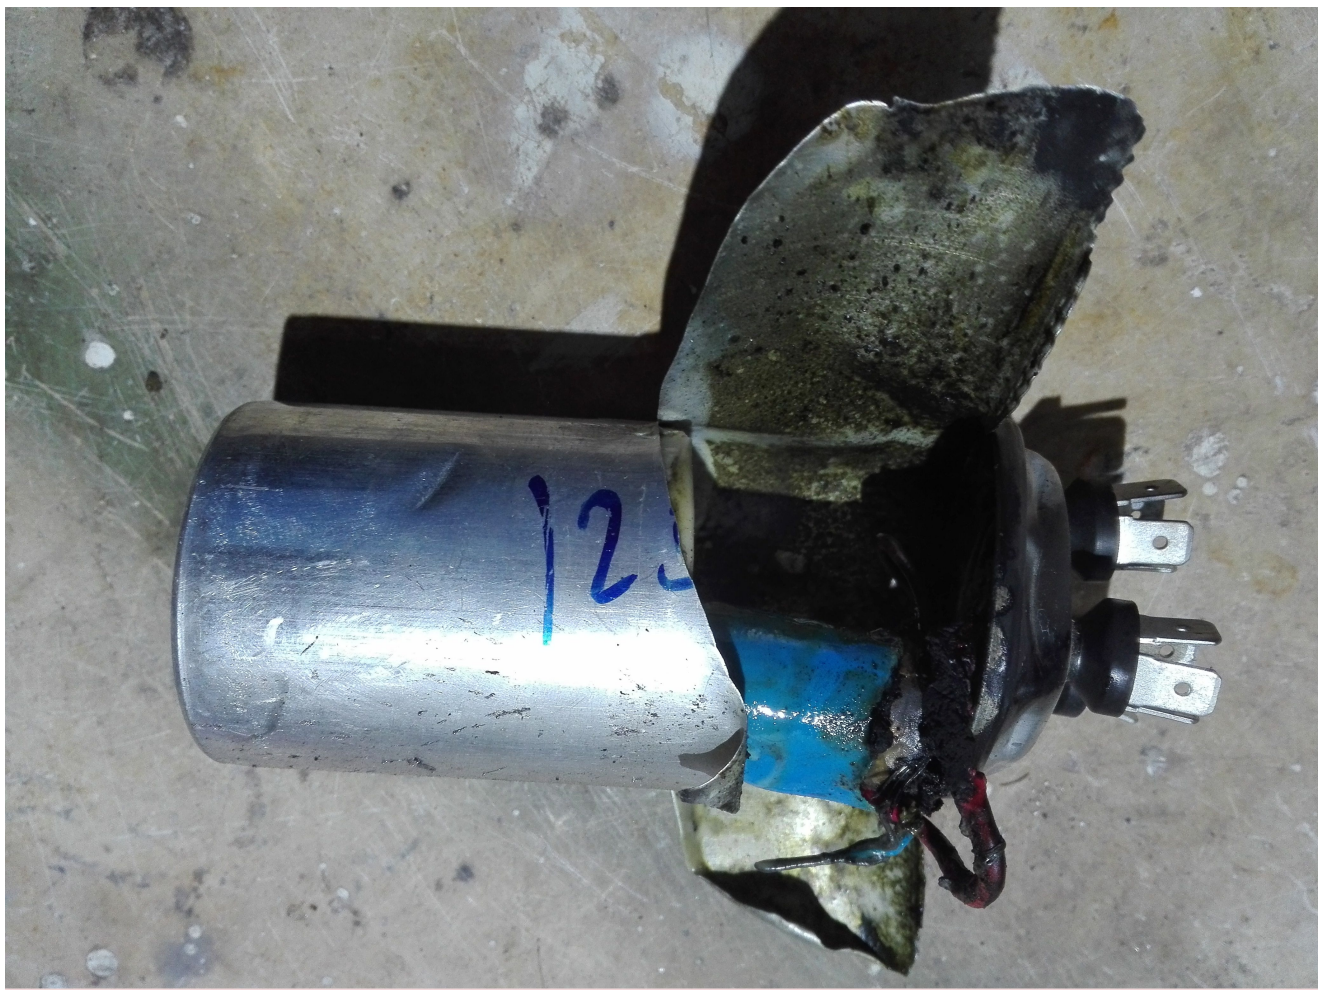
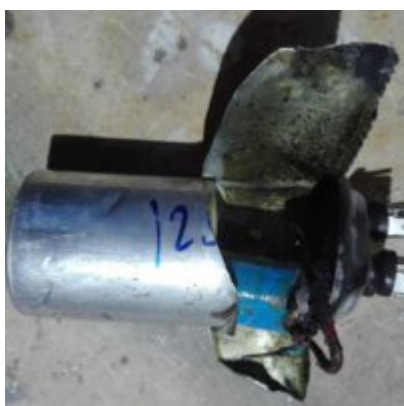
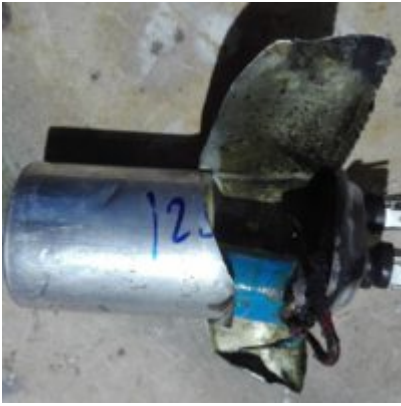
mbsm-dot-pro-capacitor-explodes- Pictures-A.jpg (4 MB)

Unexpectedly the electrolytic capacitors explodes with huge sound and sometime it smoke.

material, but the increase of leakage current that is troublesome. A rising leakage means heat which will boil the water and make steam – that's the explosion process.

This is explosion as occasional failure of the few. But there is a more spectacular explosion process – it's explosion by mistake – namely being installed backward. In such a case, the anodizing chemistry is reversed and rather rapidly, the anodized film starts to reverse, and quickly thins out at a weak spot in the rather large effective film area of the capacitor. Then we have short circuit currents and steam generation rather quickly. This sort of explosion usually fills the space (the casing or the whole room if exposed) with little shreds of aluminum foil and alkali soaked paper.
